LANDSLIDES AND RELATED FEATURES

OF THE SINKS OF GANDY, W. VA. QUADRANGLE

by
Robert J. Hackman and Roger E. Thomas
1980

OPEN FILE MAP 80-194 (F-3)

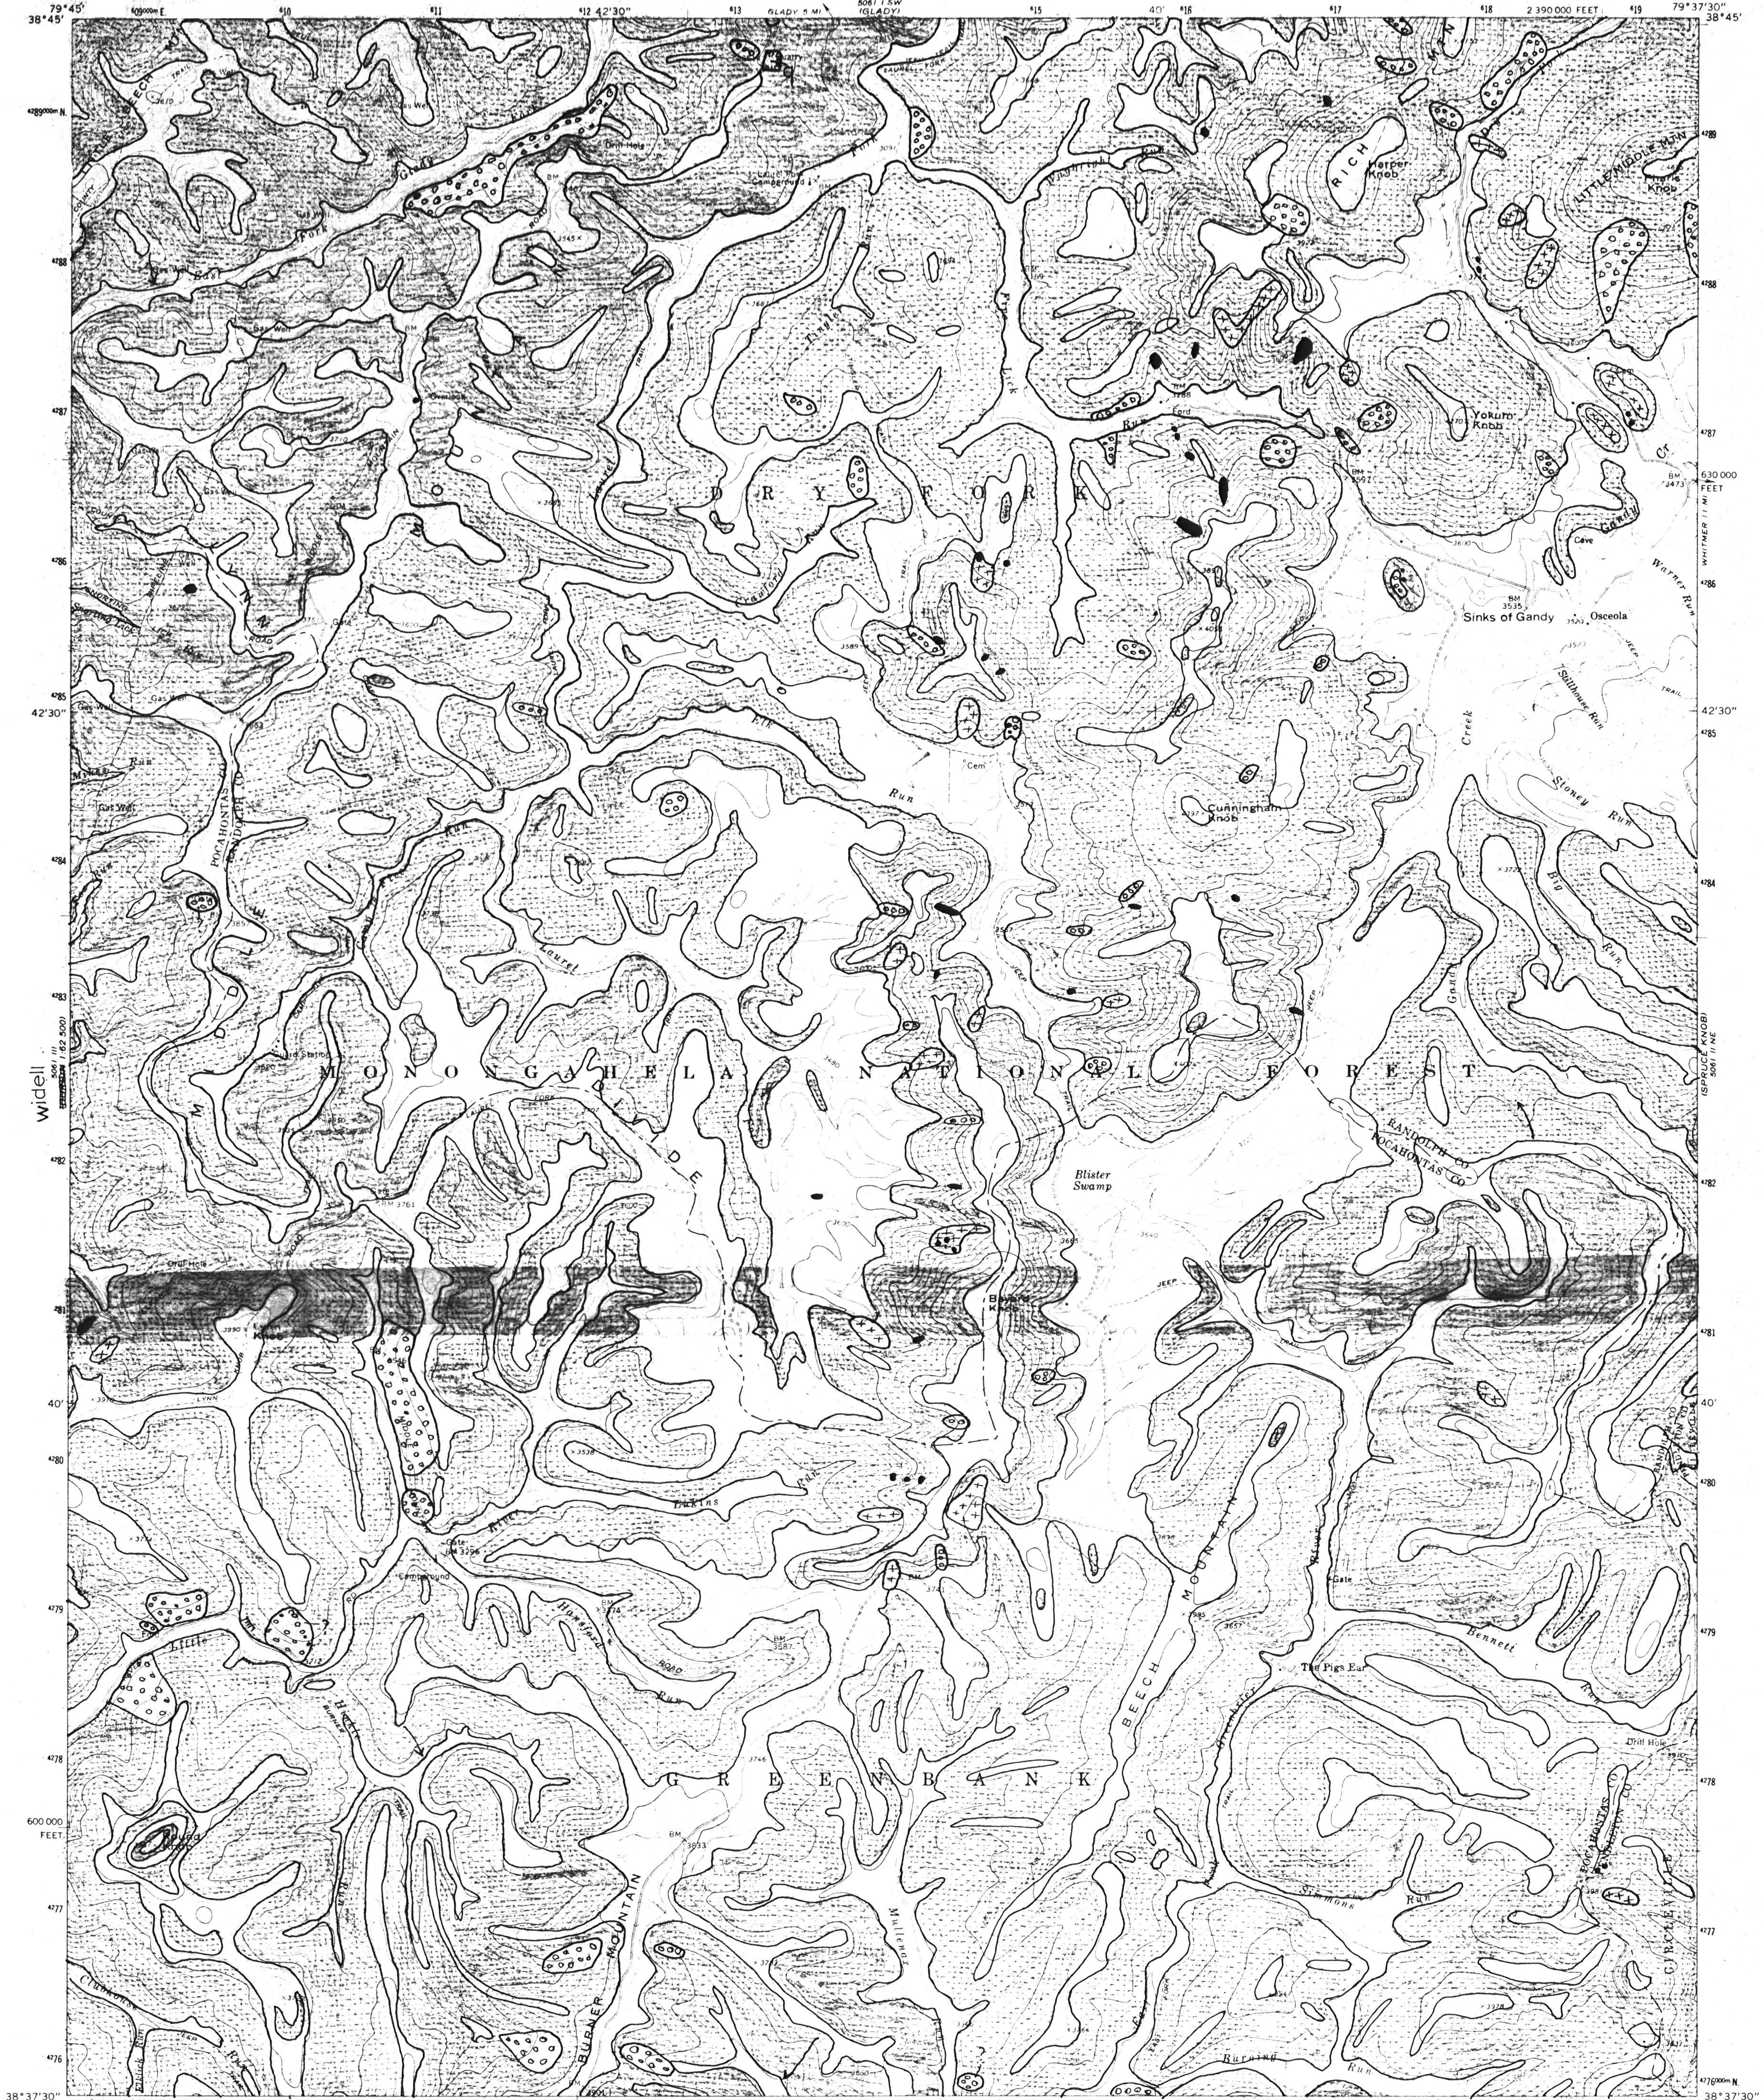
SINKS OF GANDY, W. VA.
NW 1/4 SPRUCE KNOB 15 QUADRANGLE
N 3837.5—W 7937.5/7.5
1970

LANDSLIDES AND RELATED FEATURES Interpreted from aerial photographs:

ACTIVE OR RECENTLY ACTIVE LANDSLIDE
Complex landslide composed of earthflow, debris
slide, earth and rock slump. Identified from
historical records, and from scars, debris and
other field evidence. Ground extremely unstable;
sliding accelerated by excavation, loading and
changes in drainage conditions. May include
areas with several active slides too small to
be shown separately. Questioned where doubtful.

OLD LANDSLIDE
Area of extensive hummocky ground caused by
earthflow and earth and rock slump. Lacks
clear evidence of active sliding. Relatively
stable in natural, undisturbed state,
generally not affected by small structures properly
sited in areas away from the edge of the toe;
can be reactivated by extensive, rapid exca-
vation, loading, and changes in ground water and
surface water conditions. Area of old landslide
probably includes recent ones not identified
from field evidence or otherwise documented.
Upslope boundary of landslide generally defined
by modified scarp, but downslope (toe) may be
gradational and not well defined. Questioned
where doubtful.

COMBINATION LANDSLIDE
Area of recent and old slides in which
individual slides are not identified.

COLLUVIAL SLOPE
Valley wall along major streams with slope as
steep as 40° (85%); stony, clayey silt soil up
to 50 ft. (15 m) thick; commonly buttressed by
a terrace or bench at the toe of the slope; very
susceptible to sliding by cutting of toe area,
removal of terrace or bench, and overloading;
slide commonly activated without apparent cause.

COLLUVIAL SLOPES WITH LANDSLIDES
Landslides too small or obscure to map
individually.

**AREAS SUSCEPTIBLE TO DEBRIS FLOWS AND DEBRIS
AVALANCHES**
Primarily shallow, narrow ravines and chutes with
accumulation of stony colluvium generally 10 ft.
(3 m) or less in thickness; susceptible to rapid
movement during intense rainfall. Most ravines
and chutes designated show evidence of former
debris flows and avalanches. Symbol designates historical debris flow or debris avalanche.

AREAS SUSCEPTIBLE TO ROCKFALL
Steep, locally vertical, natural and man-made
slopes and cliffs, 15 ft. (4.5 m) or more high;
formed dominantly of sandstone, limestone, sandy
shale, mudstone and claystone. Interbedded mud-
stone, claystone and shale weather rapidly leaving
sandstone and limestone rock faces unsupported.

SOIL AND ROCK SUSCEPTIBLE TO LANDSLIDING
Soil and rock similar to that involved in land-
slides elsewhere in map area; primarily areas
underlain by claystone, mudstone and shale
associated with other rock types. Rock weathers
rapidly on exposure forming clayey soil highly
susceptible to sliding. Includes coves (U-shaped,
shallow valleys) containing thick layers of clayey
soil that are very susceptible to sliding where
excavation breaks continuity of slope and where
overloaded by artificial fill.

AREAS LEAST PRONE TO LANDSLIDES
Map areas in which no patterns or symbols are shown;
primarily valley floors, ridge tops and broad
benches; modification by excavation and fill may
lead to local landslides.

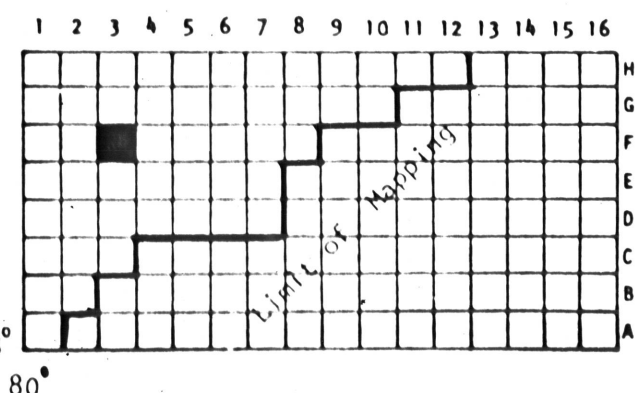
Charlottesville 1° by 2° sheet

The first five digits of the open file number designate the
specific 1:250,000 scale map sheet of which this quadrangle
is a part. The last two digits designate the position of the
quadrangle in a subdivision of the 1:250,000 scale map based
on rows and tiers shown in the diagram to the right. The
location of this quadrangle is shown by the black square.
